检 验 报 告

TEST REPORT

报告编号 : FH2015NG0087
Report No.

样品名称: 水泥板面结构保温板 (cSIPs) 外墙
Sample Name: Cementitious Structural Insulated Panels Components for Exterior Wall

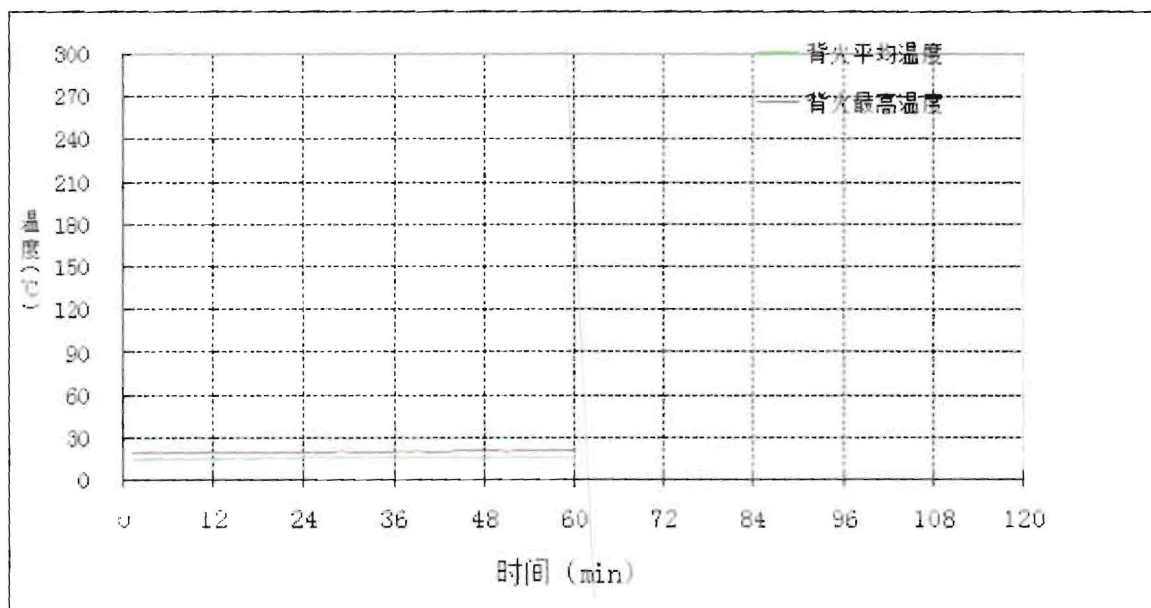
图2 背火温升曲线

Figure 2 Temperature rise curve of back surface

序号 No.	检验项目 Test Item	标准要求 Standard Requirements	检验结果 Test Result	单项判定 Individual Judgment
1	耐火极限 Fire-resistance	<p>试件背火面温度温升发生超过以下任一限定的情况均认为试件丧失隔热性:</p> <p>a) 平均温度温升超过初始平均温度140℃;</p> <p>b) 任一点位置的温度温升超过初始温度(包括移动热电偶)180℃(初始温度是试验开始时背火面的初始平均温度)。</p> <p>Surface temperature rise of specimen back is over the following any qualified happens that the specimen is loss of thermal insulation:</p> <p>a) The average temperature rise exceeds the initial average temperature 140 °C;</p> <p>b) The temperature rise of any point(Including mobile thermocouple)exceeds the initial temperature 180 °C(The initial temperature is the initial average temperature of the back surface at the beginning of the test).</p>	<p>1.0h (60min) 时,</p> <p>a) 平均温度温升为1℃, 未超过初始平均温度140℃;</p> <p>b) 最高温度温升为6℃, 未超过初始温度(包括移动热电偶)180℃;</p> <p>试件未丧失隔热性。</p> <p>委托方要求终止试验。</p> <p>At 1.0h (60min) ,</p> <p>a) The average temperature rise of 1℃, not exceeding 140℃ of the initial average temperature;</p> <p>b) he highest temperature rise of 6℃, not exceeding 180℃ of the initial temperature(Including mobile thermocouple).</p> <p>The specimen is without loss of thermal insulation.</p> <p>The client requests the test termination.</p>	符合 Meet
