检 验 报 告

TEST REPORT

报告编号: FH2015NG0089
Report No.

OSB面结构保温板 (oSIPs) 屋面
OSB skin Structural Insulated Panels
Components for Roof

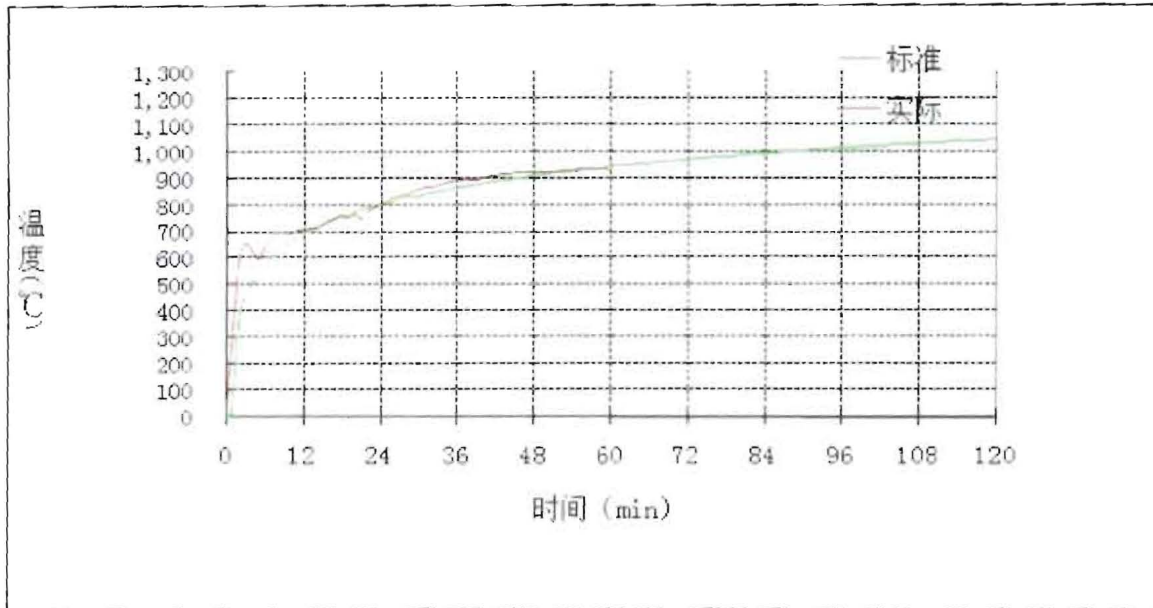
图1 炉内升温曲线
Figure 1 Temperature rise curve of furnace

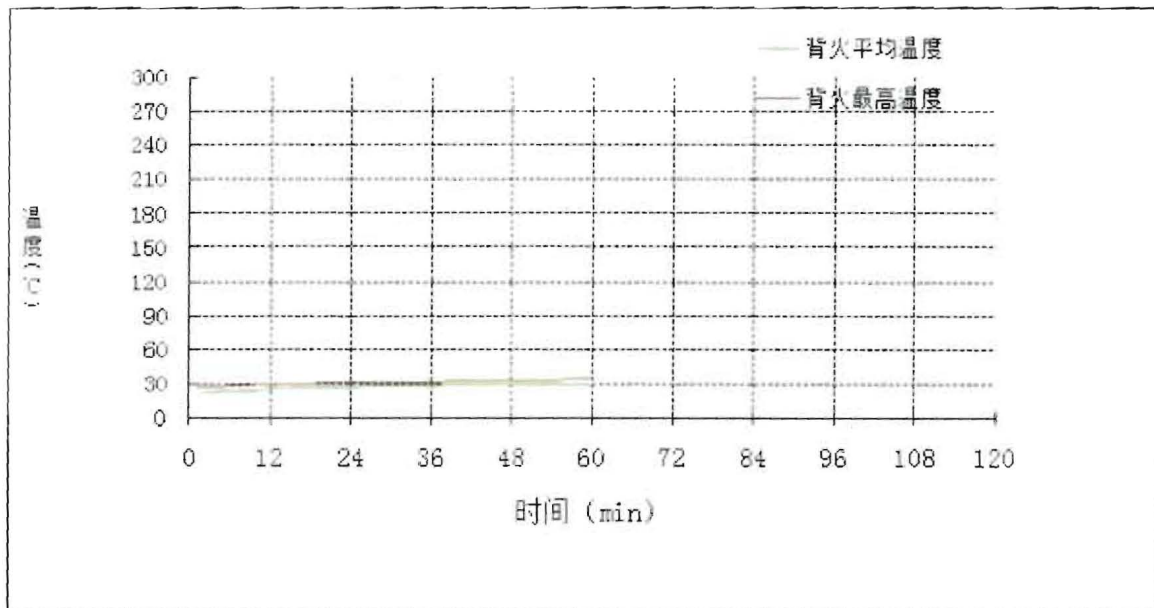
图2 背火温升曲线
Figure 2 Temperature rise curve of back surface

序号 No.	检验项目 Test Item	标准要求 Standard Requirements	检验结果 Test Result	单项判定 Individual Judgment
1	耐火极限 Fire-resistance	<p>隔热性 Thermal insulation</p> <p>试件背火面温度温升发生超过以下任一限定的情况均认为试件丧失隔热性: a) 平均温度温升超过初始平均温度140℃; b) 任一点位置的温度温升超过初始温度(包括移动热电偶)180℃(初始温度是试验开始时背火面的初始平均温度)。 Surface temperature rise of specimen back is over the following any qualified happens that the specimen is loss of thermal insulation: a) The average temperature rise exceeds the initial average temperature 140℃; b) The temperature rise of any point(Including mobile thermocouple)exceeds the initial temperature 180℃(The initial temperature is the initial average temperature of the back surface at the beginning of the test).</p>	<p>1.0h (60min) 时, a) 平均温度温升为9℃, 未超过初始平均温度140℃; b) 最高温度温升为13℃, 未超过初始温度(包括移动热电偶)180℃; 试件未丧失隔热性。 委托方要求终止试验。 At 1.0h (60min), a) The average temperature rise of 9℃, not exceeding 140℃ of the initial average temperature; b) The highest temperature rise of 13℃, not exceeding 180℃ of the initial temperature(Including mobile thermocouple). The specimen is without loss of thermal insulation. The client requests the test termination.</p>	符合 Meet

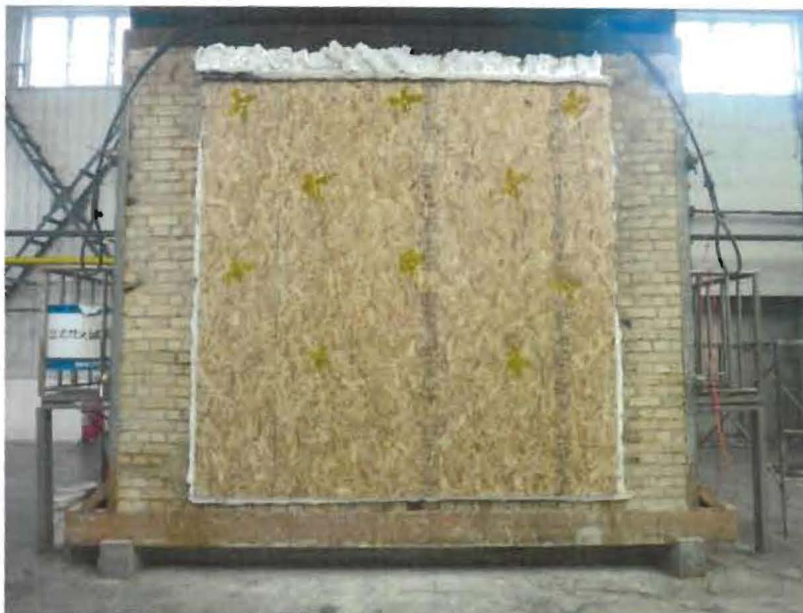
图3 试件试验前背火面
Figure 3 Back surface of specimen before test

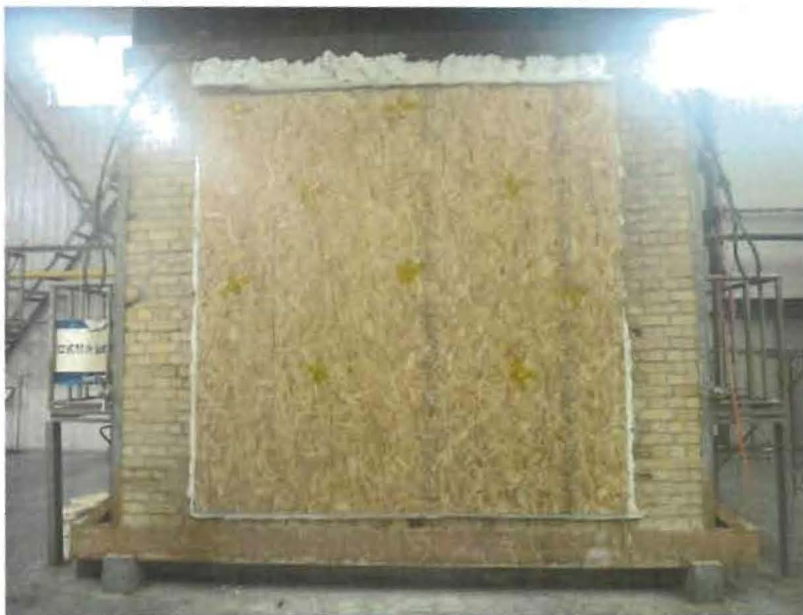
图4 试件试验后背火面
Figure 4 Back surface of specimen after test

完整性 Integrity	<p>试件发生以下任一限定情况均认为试件丧失完整性: a) 棉垫被点燃; b) Φ6mm的缝隙探棒穿过试件进入炉内, 并沿裂缝方向移动150mm的长度; Φ25mm的缝隙探棒穿过试件进入炉内; c) 背火面出现火焰并持续时间超过10s。 The following any qualified happen that the specimen is loss of integrity: a) Pads was lit b) Φ 6mm probe gap through the specimen into the furnace, and along the fracture direction of 150 mm in length; Φ 25mm probe gap through the specimen into the furnace; c) Back surface appears flames and lasts more than 10s.</p>	<p>1.0h (60min) 时, a) 棉垫未被点燃; b) 未出现裂缝; c) 背火面无火焰; 试件未丧失完整性。 委托方要求终止试验。 At 1.0h (60min), a) Pads are not lit; b) No cracks; c) No flame on back surface. The specimen is without loss of integrity. The client requests the test termination.</p>

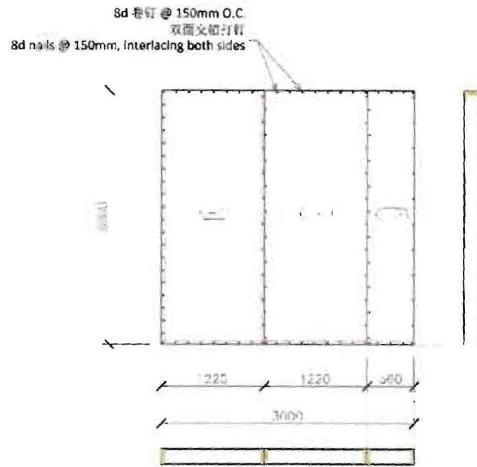
图5 试件拼装示意图
Figure 5 Assembly diagram of the Specimen

OSB面结构保温板 (oSIPs) 屋面板
结构部分210mm 共1组
210mm thick OSB skin Structural Insulated
Panels for Roof 1 group

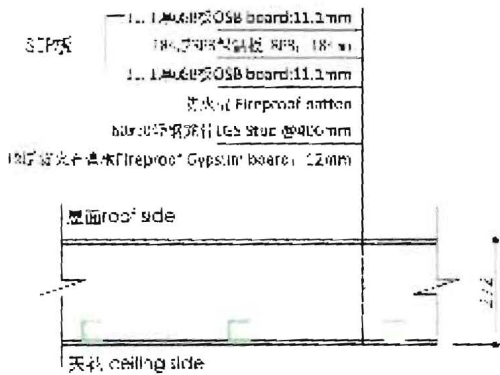
图6 试件构造及节点示意图
Figure 6 Structure and node diagram of the specimen

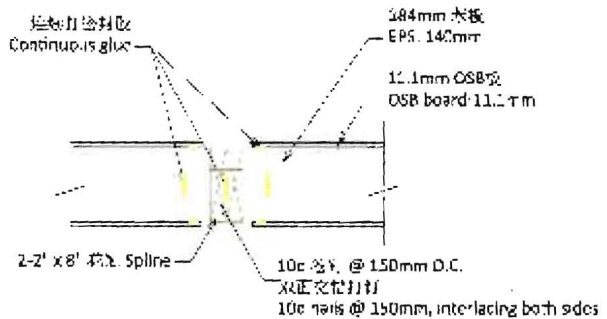
oSIPs 屋面板构造图
OSB skin Structural Insulated
Panels Components for Roof

oSIPs 屋顶结构连接通用节点
oSIPs Roof panel structural connection details
SCALE: 1:50
